R-Values in the Real World

www.sips.org P.O. Box 1699, Gig Harbor, WA 98335 p: 253.858.7472 f: 253.858.0272 Copyright © 2009 Structural Insulated Panel Association (SIPA). All rights reserved.

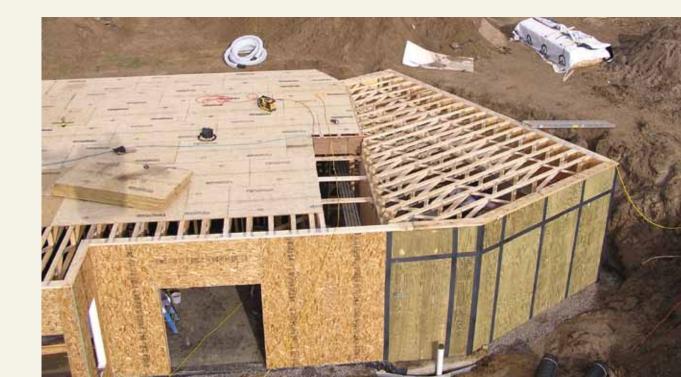
LOCATION:	Andover, Minnesota
BUILDER:	Panel Setters Plus, Inc.
SIZE:	4,934 sq. ft.
HERS INDEX:	40
INFILTRATION:	0.48 ACH50
BUILDING ENVELOPE:	 Basement: R-32 SIPs Walls: R-24 SIPs Roof: R-48 SIPs
HVAC:	4-ton geothermal system, heat recovery ventilator, efficient natural gas furnace as backup heat source

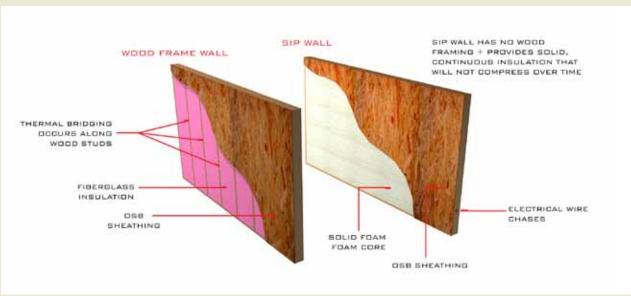
SIP Walls are Engineered to Minimize Thermal Bridging

When field-installed insulation is measured in the laboratory, the test only measures the insulation itself, and not the other components that make up the wall or roof system. Wood-framed homes rely on dimensional lumber, referred to as studs, at regular intervals to provide structural support. Lumber is a very poor insulator and forms a bridge from the outside of the home to the inside of the home where heat can pass through by conduction. This process is known as thermal bridging.

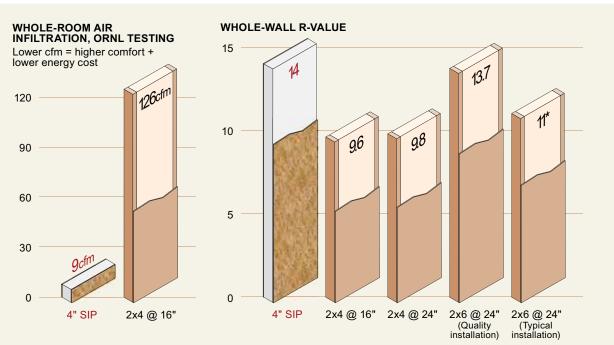
* Tests show that in the "worst case commonly found of procedures for installing batt insulation" the performance drops to R-11. Figure courtesy of APA.

Oak Ridge National Laboratories has led the building industry in defining whole wall R-value, an increasingly popular metric that tests the thermal resistance of an entire wall section. A 2x6 wall with R-19 fiberglass insulation turns out to be R-13.7 when the thermal bridging of studs every 24 inches is considered.

Building with SIPs does not require any insulation to be installed in the field. There is very little dimensional lumber required to build a SIP home because SIPs are structurally sufficient. ORNL tests prove that SIPs maintain their full R-value in whole wall testing.
